# Bell Home Inspections June 19th 2023, 6:50 pm

Inspection performed by: Scott Bell

**INSPECTION DESCRIPTION:** SINGLE FAMILY LOG HOME

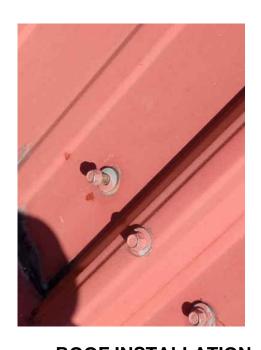
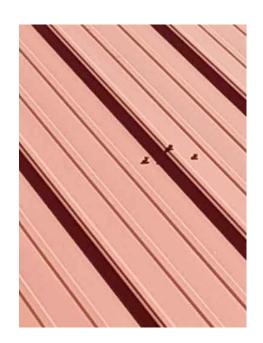
Some loose screws. Recommend repairing or replacement by qualified roofer.
