# Bell Home Inspections

### General Information

**BUILDING ADDRESS:** 123 Sample St  
**CITY:** SI Sample  
**STATE / PROVINCE:** Idaho  
**POSTAL CODE:** 83800  
**INSPECTION DESCRIPTION:** Single story Residence  
**SQUARE FOOTAGE:** 1044

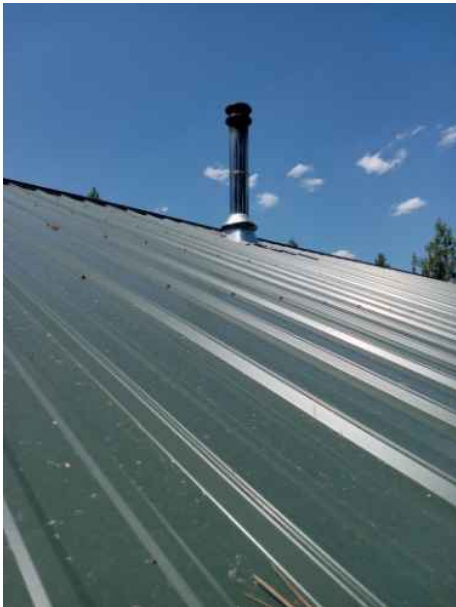
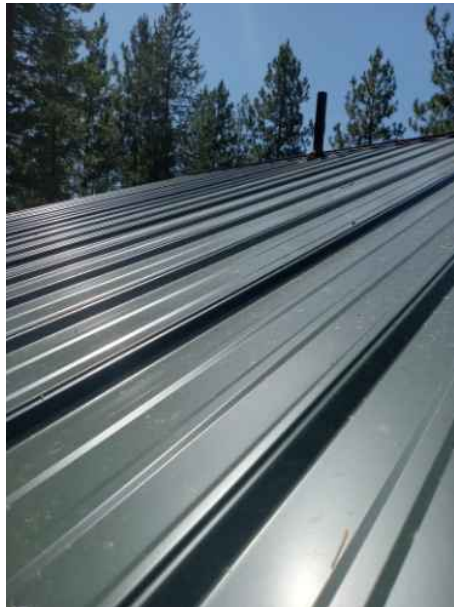
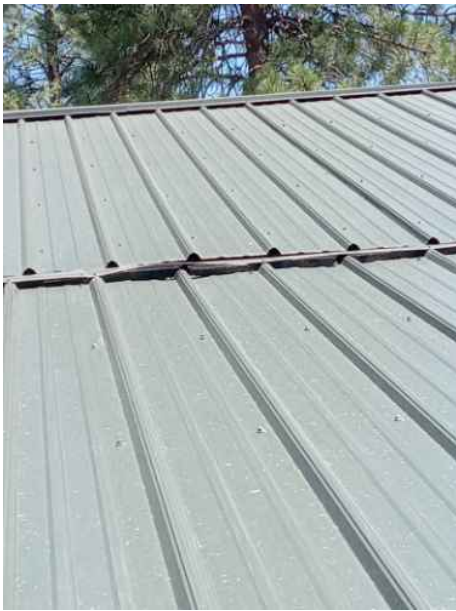
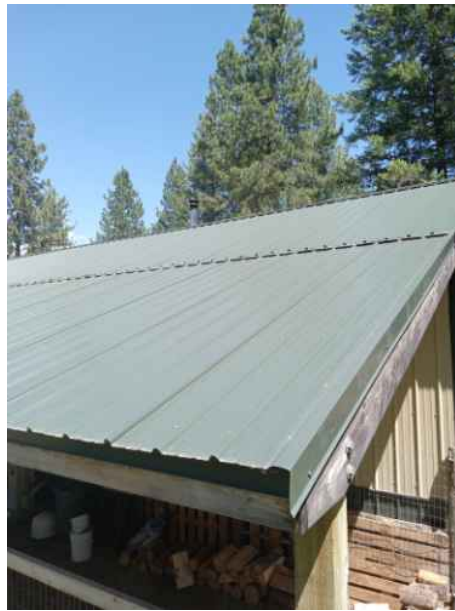
**ROOF MATERIAL** Metal Standing Seam

Flashing between roof and carport a little bent out of shape. No leak visible at this time. Recommend monitoring.

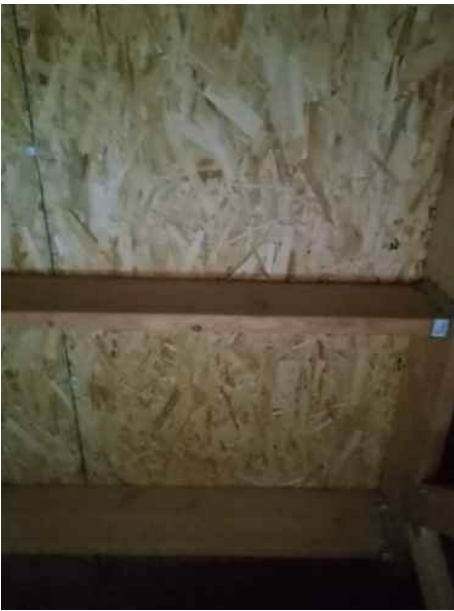
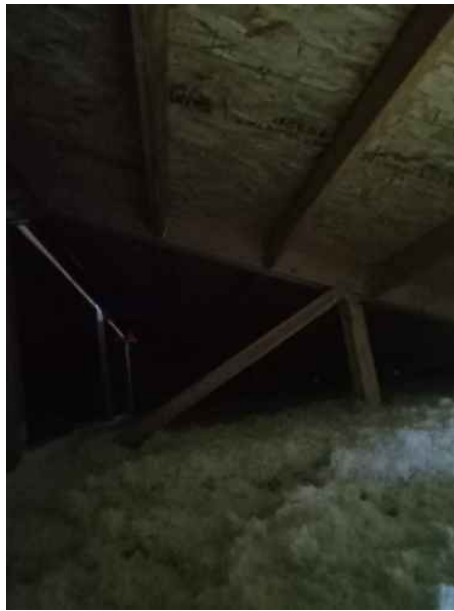
**ROOF SHEATHING** Satisfactory

Pole building style framing with rafter and perlins.

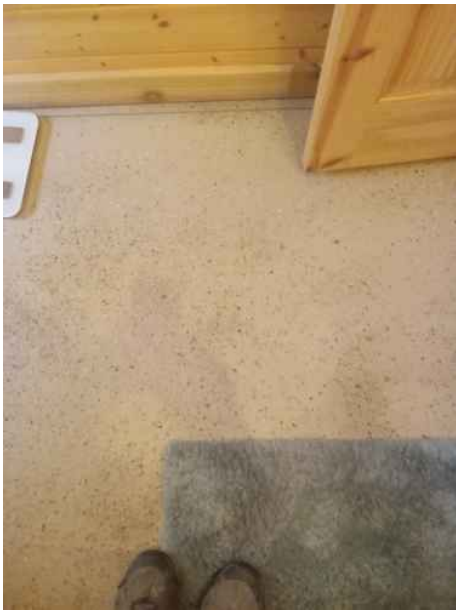
**FLOORING** Satisfactory

Concrete with texture

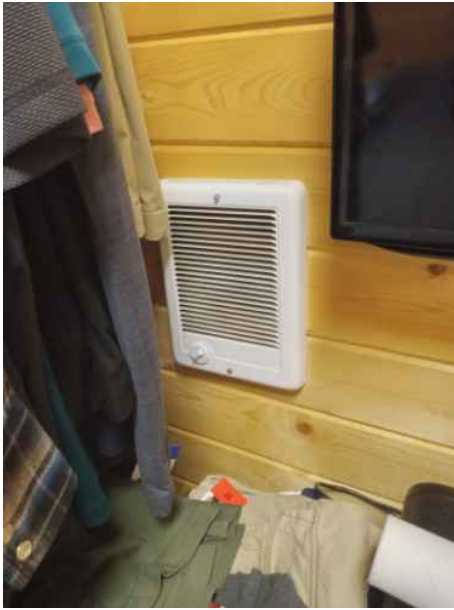
**WALLS** Satisfactory

Wall mount heater, not tested, over 60 degrees outside.

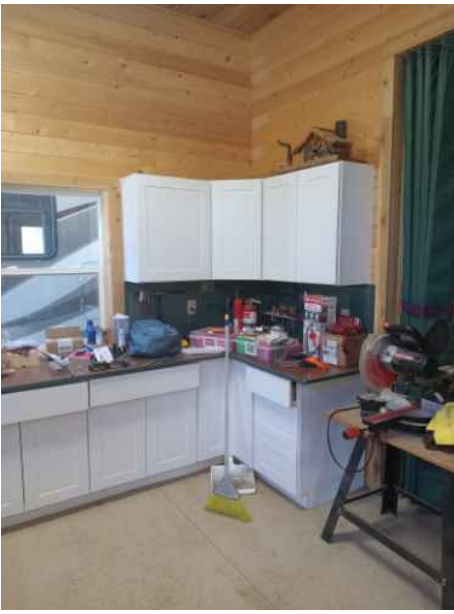
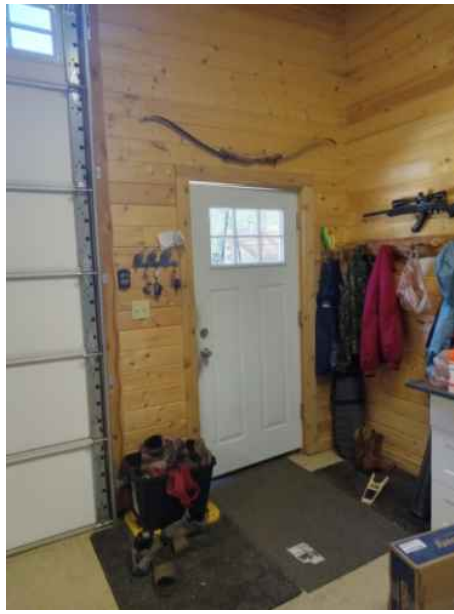
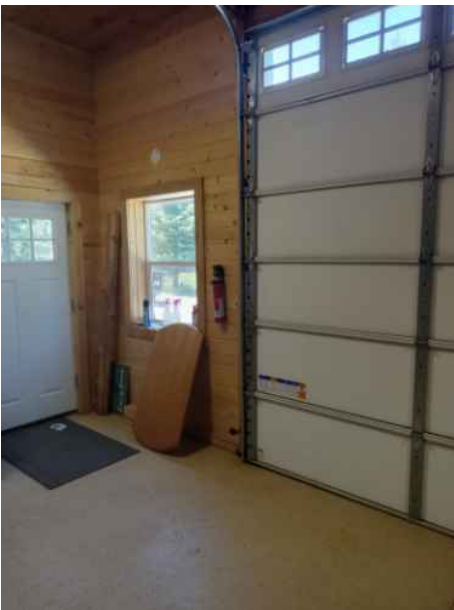
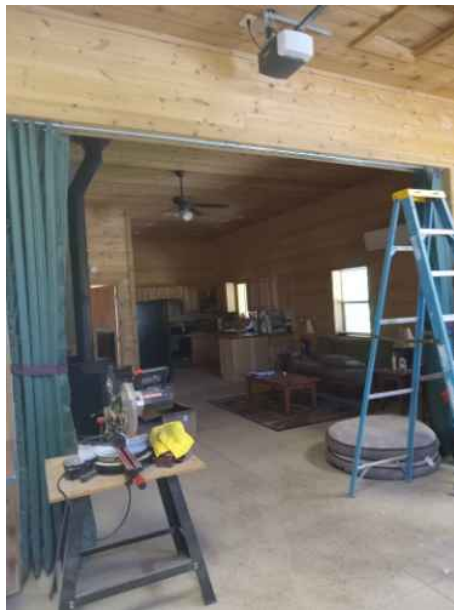
**WALLS** Satisfactory

Shop area is the entry area.

Has insulation roll back drapes for keeping cold out in winter months

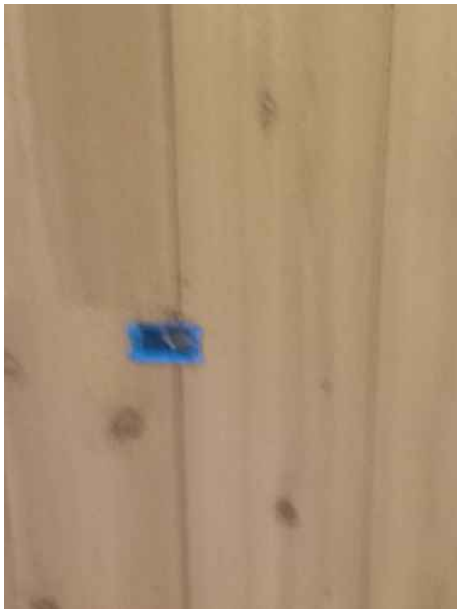
**LIGHTING** Satisfactory

Electrical box with no face plate. Recommend further evaluation by licensed electrician for safety.

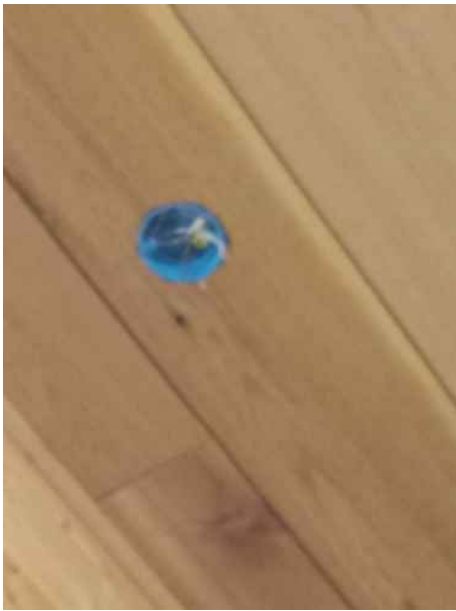
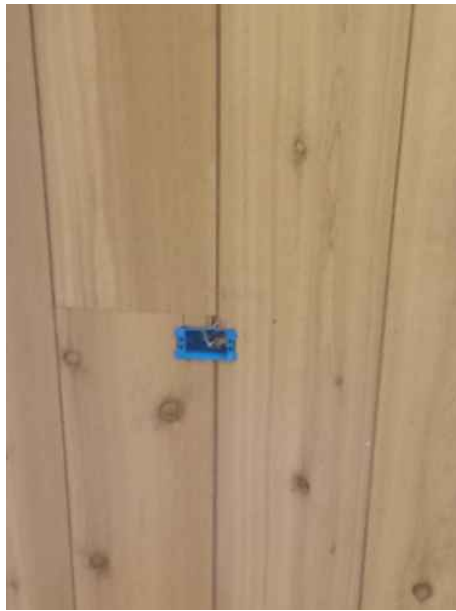
**LIGHTING** Satisfactory

Undercover electrical box in ceiling.

Recommend further evaluation by licensed electrician for safety.

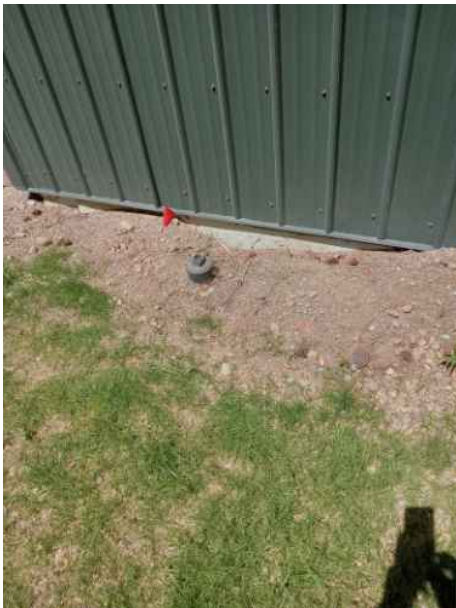
**DRAINAGE** Inspected

Low spot in grade by clear out on south side. Recommend further evaluation by landscape contractor for drainage

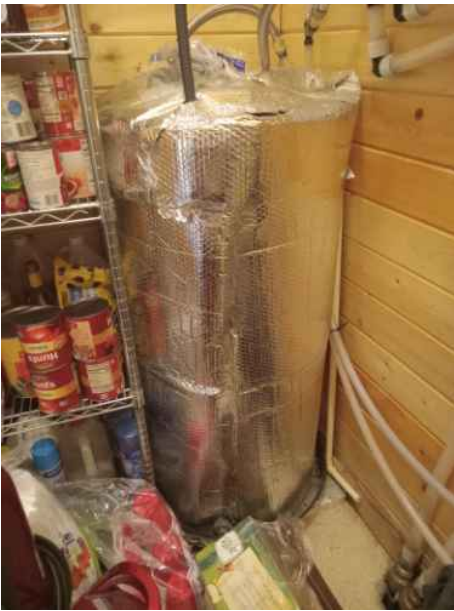
**WATER HEATER** Satisfactory

Water heater covered with blanket. Cannot see model number or needed info.

Per owner, it was new in 2016 when house was built

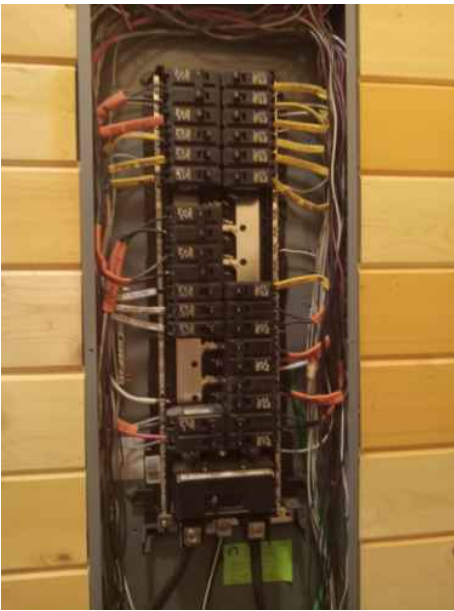
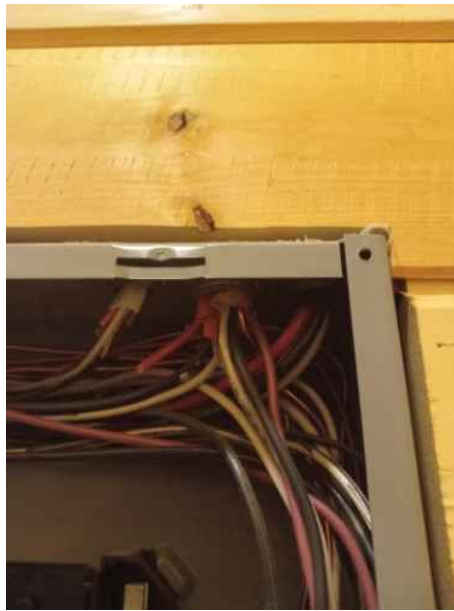
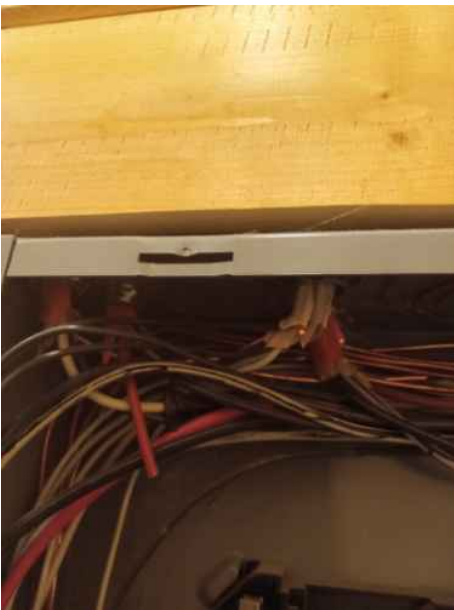
**CIRCUIT PANEL** Fair

Wires in panel cut off. Recommend further evaluation by licensed electrician for safety.
